# Photovoltaics for Buildings: New Applications and Lessons Learned

*Sheila J. Hayter, Paul A. Torcellini, Michael P. Deru  
National Renewable Energy Laboratory*

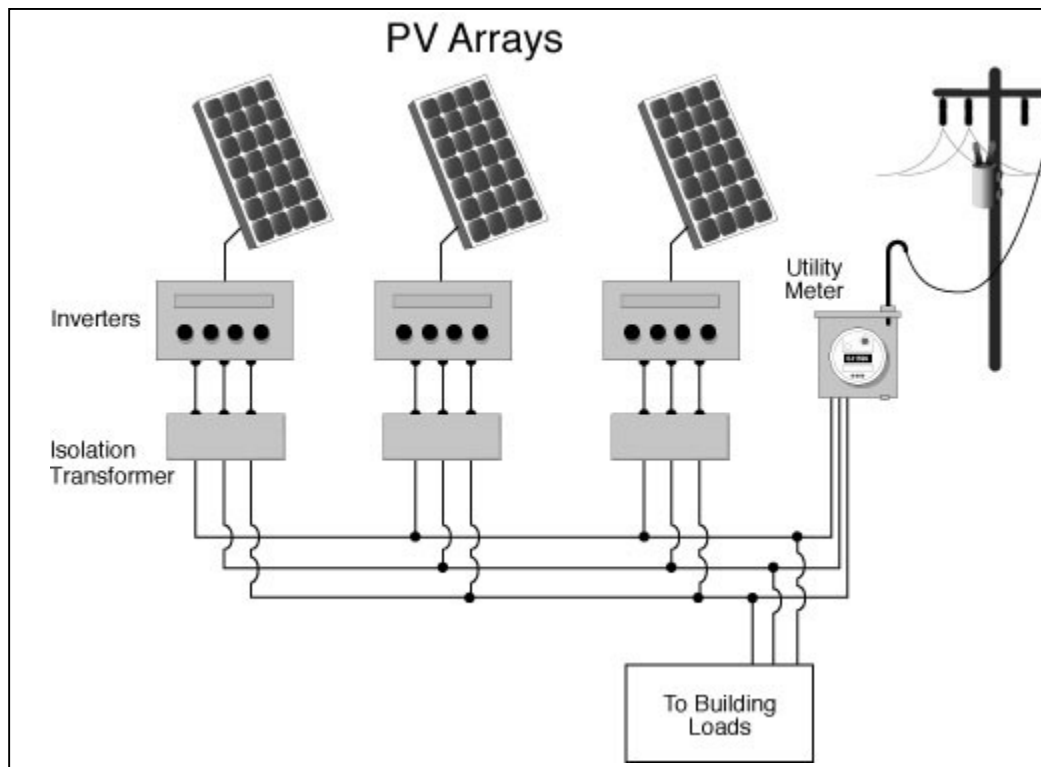
**Figure 2. Lewis Center for Environmental Studies PV System Configuration**

Each sub array is linked to its own 15-kW, 3-phase, grid-tied inverter (Figure 2). The inverters are connected to the building's main distribution panel through 15-kVA isolation transformers, one transformer for each of the three inverters. Note that the combined capacity of the inverters is smaller than the rated capacity of the modules to make more efficient use of the inverters. It is rare that the sub array outputs exceed the 15-kW rating of each inverter.

Monitoring equipment to measure the Lewis Center for Environmental Studies PV system performance consists of DC Watt transducers located between each sub array and the corresponding inverter, an AC Watt-hour meter between the system AC disconnect and the building main distribution panel, and an AC Watt-hour meter downstream of the main distribution panel.

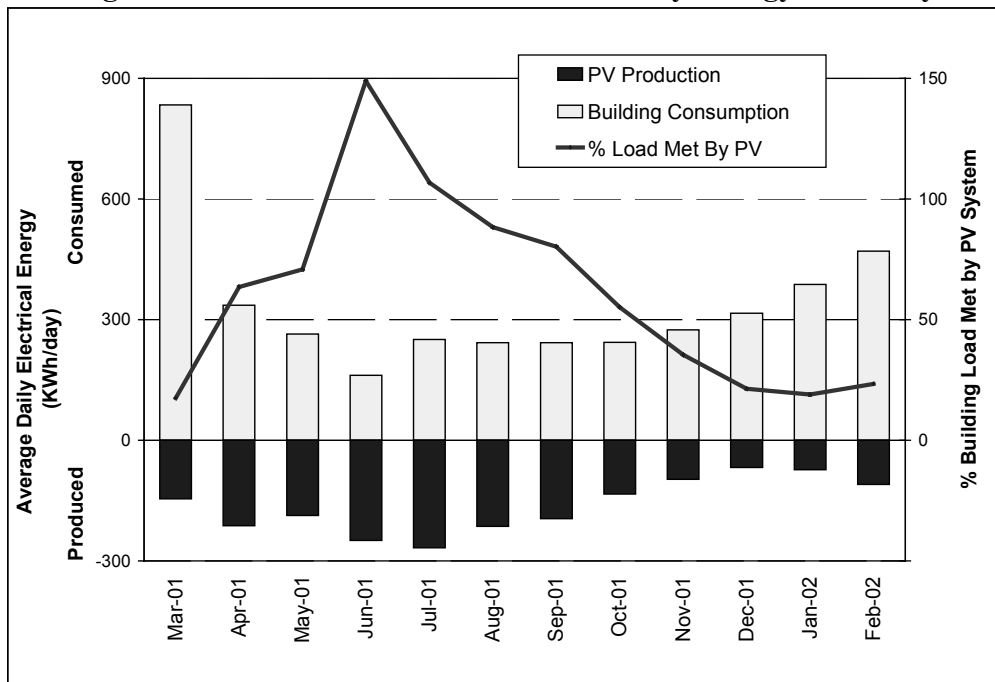
**Figure 3. Lewis Center Normalized Monthly Energy Summary**

**Photovoltaic system performance.** Figure 3 summarizes the building’s average daily electrical energy loads per month. This information is based on actual performance data. The line representing the percent of the total building energy load met by the PV system indicates that the PV system produced more power than was needed to meet the building’s demands during two months and that more than two-thirds of the building’s electrical loads were offset by the PV system during an additional 4 months.

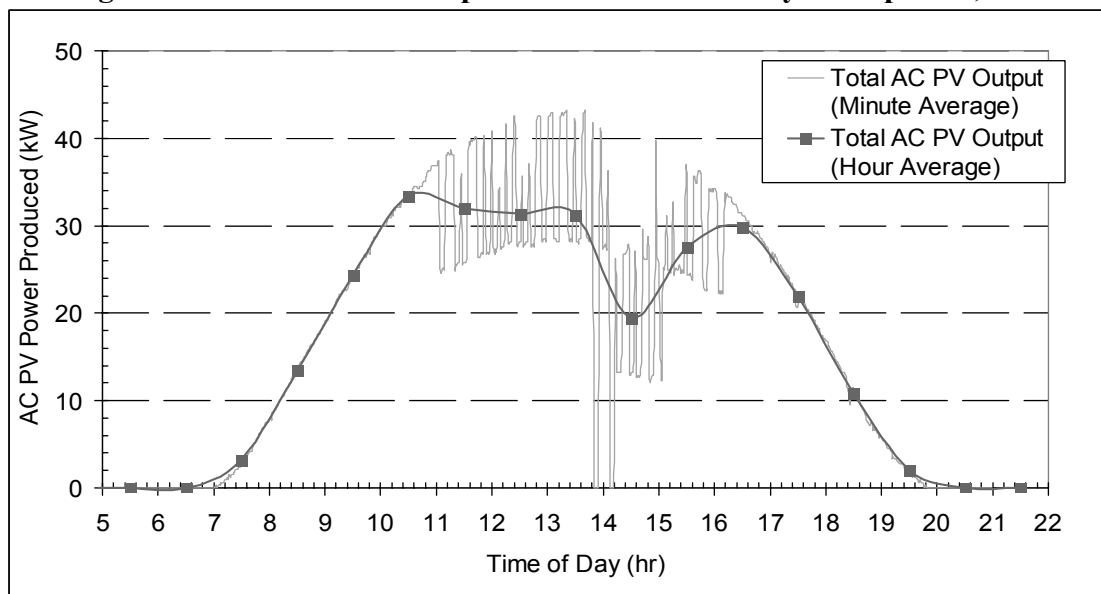
**Figure 4. PV AC Power Output for Three Sub Arrays on April 28, 2001**

Careful examination of the PV system performance showed that on some days, the inverters would shut down repeatedly for short periods (Figure 4). Daily hourly average power production data appeared to show that a cloud had passed by in mid afternoon, not that there was a system performance issue. The system performance problem was seen when reviewing the minute-by-minute performance data. On cool, sunny days, the PV system supplied more power to the inverter than its capacity. The result was an over-voltage fault. Work is still being done to rectify this situation.

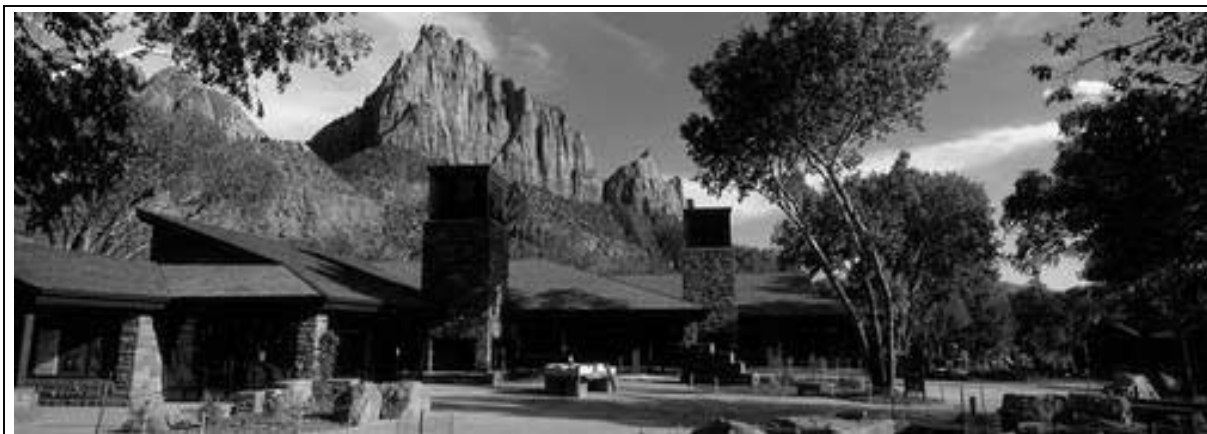
**Figure 5. Zion Visitor Center**

The roof-mounted, grid-tied PV system is mounted to the south roof of the Visitor Center nearly flush with the 4/12-pitched roof (18.4°). The array is composed of 24 300-W modules divided equally into two sub arrays. The sub arrays are configured identically—an east array and a west array. Each sub array is rated for 3600 watts and consists of three parallel strings comprising four modules in series to create a 48-V system. Figure 6 diagrammatically shows that one sub array charges the building UPS system batteries and the other is tied directly to the building electrical panel. The UPS system contains 200 Ah of battery capacity.

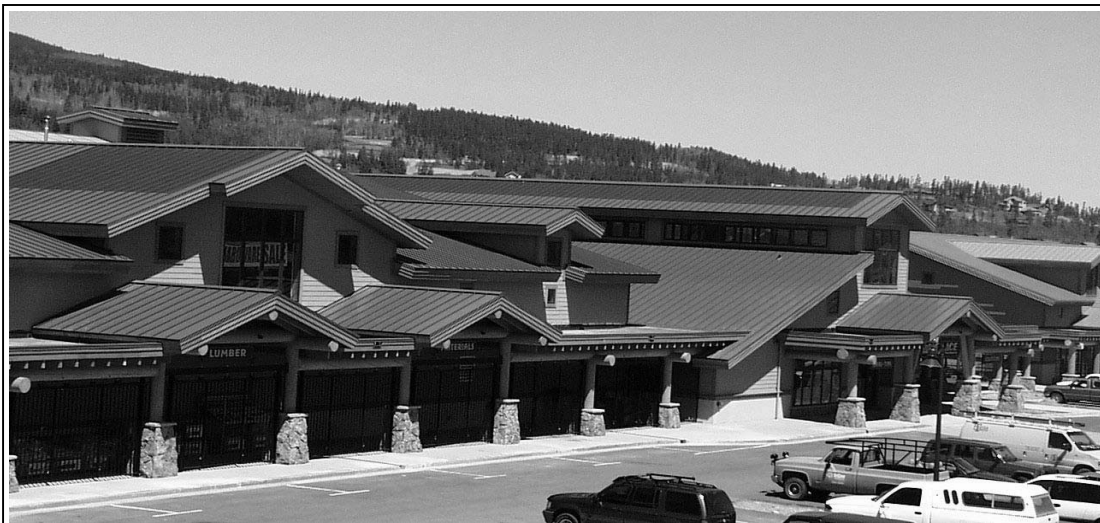
**Figure 8. BigHorn Home Improvement Center**

An 8.88-kW, thin-film PV system is integrated into the standing-seam metal roof (Figure 8). The roof-integrated PV system is a durable and practical solution for buildings in this alpine climate because of the high amount of snowfall and ice buildup on the roof. The system consists of 18 120-W modules and 105 64-W modules.

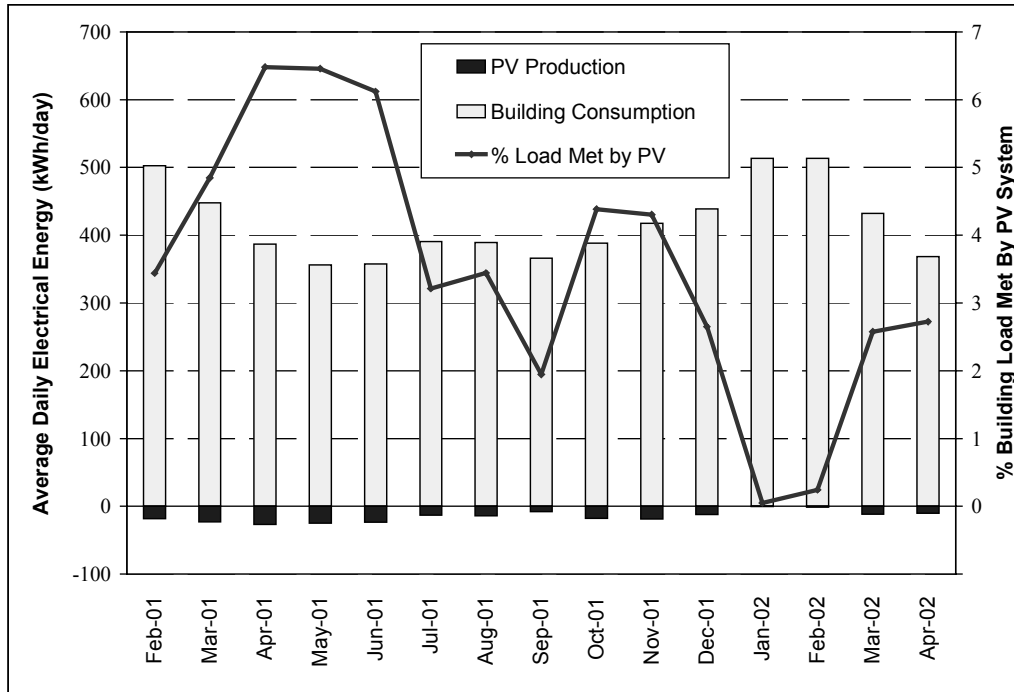
**Figure 10. BigHorn Center Normalized Monthly Energy Summary**

Figure 10 summarizes the building average daily electrical energy loads and PV system production per month. The percent of the total building electrical load met by the PV system peaked around 6.5% in April 2001.
