A Systems Approach to Retrofitting Residential HVAC Systems

Jennifer A. McWilliams and Iain S. Walker, Lawrence Berkeley National Laboratory,

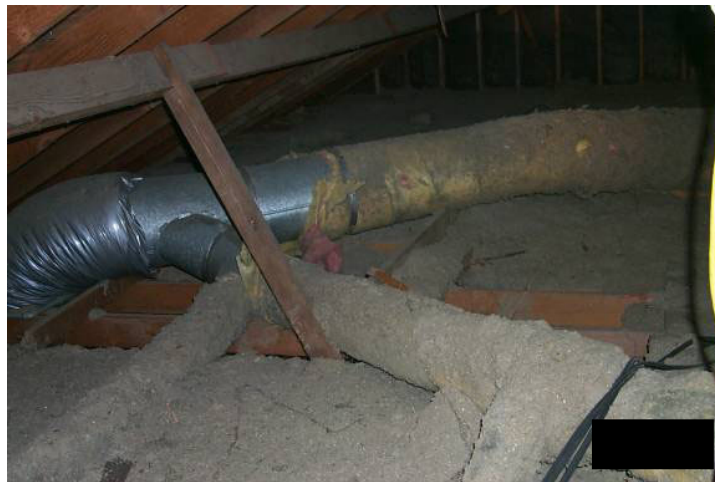
Figure 2. Poorly Insulated Sheet Metal Ducts and Blown-In Insulation in the Attic before Retrofit

- The metal ducts in the attic were replaced with new R-4 flexible ducts (despite clear and repeated instruction to retain the original ducts) because the contractor thought they were undersized. Initially the contractor hung the flex-ducts from the attic ceiling with smooth bends. However, to allow covering the ducts with insulation the contractor then placed the new ducts on the floor, but unfortunately did not take the time to lay the ducts with smooth bends.

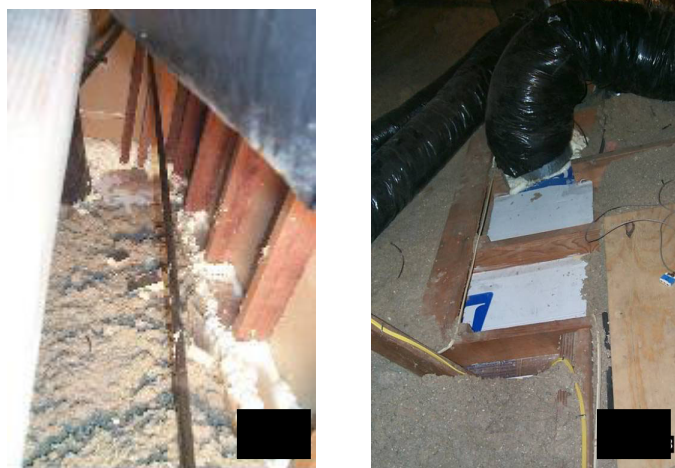
Figure 3. Sealing Cavities Connecting the House to the Attic

Foam was used for sealing small holes and cracks at building component intersections (left).
Duct board insulation was used to block off large open areas (right).

The sealing of the envelope was very successful – mostly because this particular house had significant large leaks that we were able to access. We sealed over 570 L/s (1200 cfm) of leakage at 50 Pa (0.2 in. water)) - about one-quarter of the total leakage. The sealing included: air-sealing the attic floor plane (2 large chases) as shown in Figure 3, leaks between the old cavity return (which communicated with the garage) and the conditioned space, and plumbing penetrations in the conditioned space.

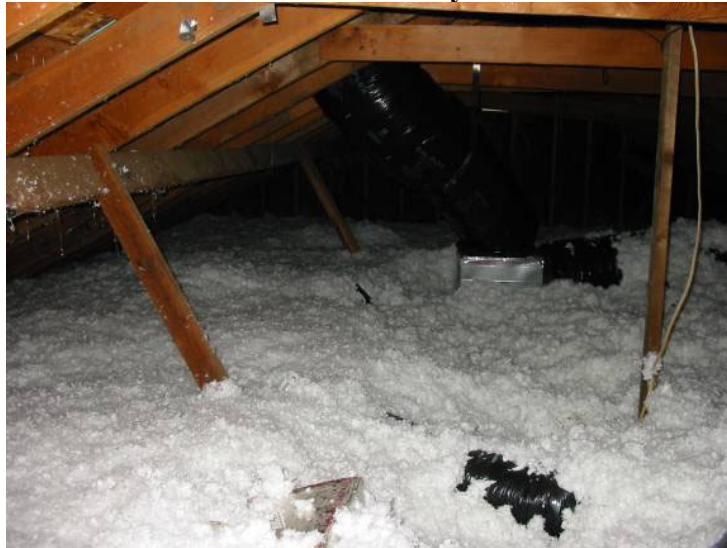
Figure 4. New Flex Ducts in Attic Covered by Additional Blown-In Insulation

Because the ducts, furnace, and air handler were located in the attic, the original retrofit plan was to seal and insulate the attic to bring the system inside conditioned space. Unfortunately, it was not possible to obtain code approval for this retrofit in the available time. As an alternative, it was decided to place the ducts on the attic floor and cover them with blown-in insulation (as illustrated in Figure 4), thus increasing the effective insulation of the ducts and protecting them from the radiation from the underside of the roof deck. Thus, the added attic insulation served two purposes: it increased the envelope insulation and improved the distribution system performance. With sufficient time and resources, it may have been possible to persuade the code authorities to allow a sealed attic. However, as in most real retrofit situations, limits of time meant that the vented attic was retained and the ducts were buried in additional ceiling insulation. Given the strict conservatism of code officials, it is unlikely that these issues can be dealt with on an individual project basis without extensive advance planning. Hopefully, research projects like the current study will mean that innovative building changes will become more widely accepted.
