Lessons Learned from Field Evaluation of Six High-Performance Buildings

*Paul A. Torcellini, Michael Deru, Brent Griffith, Nicholas Long, Shanti Pless,
and Ron Judkoff, National Renewable Energy Laboratory
Drury B. Crawley, U.S. Department of Energy*

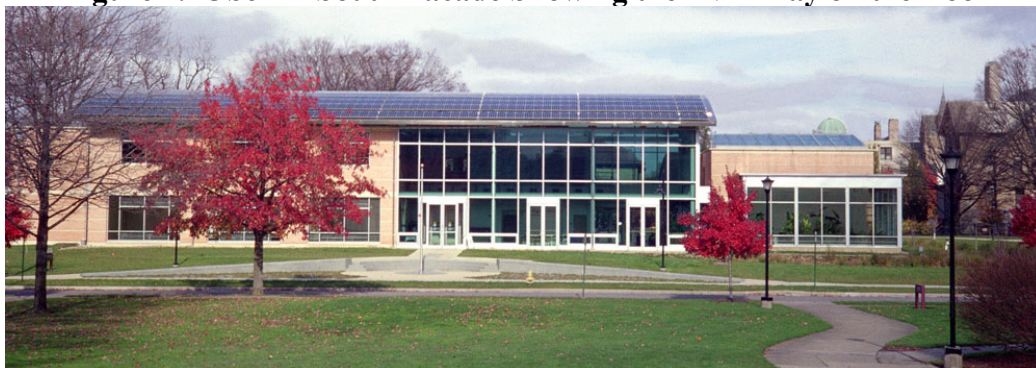
Figure 1. Oberlin South Facade Showing the PV Array on the Roof

The Oberlin College Lewis Center for Environmental Studies is a two-story, 13,600-ft² classroom and laboratory building (Figure 1). The building contains four classrooms, a small auditorium, atrium, staff offices, and kitchenette. The vision for this building was to create a building that has the potential to be a net zero energy building either now or in the future as technologies improve. The building was funded through private donations and although cost was a concern, it was not a primary driver. The object was to promote technologies and serve as an educational tool for the Environmental Studies Program at the College.

The integrated building design includes daylighting to offset lighting loads, natural ventilation to offset building cooling loads, massive building materials to store passive solar gains, a ground-source heat pump system to meet the cooling and heating loads, an energy management system, and a system to process building waste water without sending the waste to the municipal sewage treatment plant. Because of the zero-energy vision, the building was designed to be all-electric, such that onsite energy could potentially offset 100% of the energy consumed. The building's roof is covered with a grid-tied, 60-kW photovoltaic (PV) array.

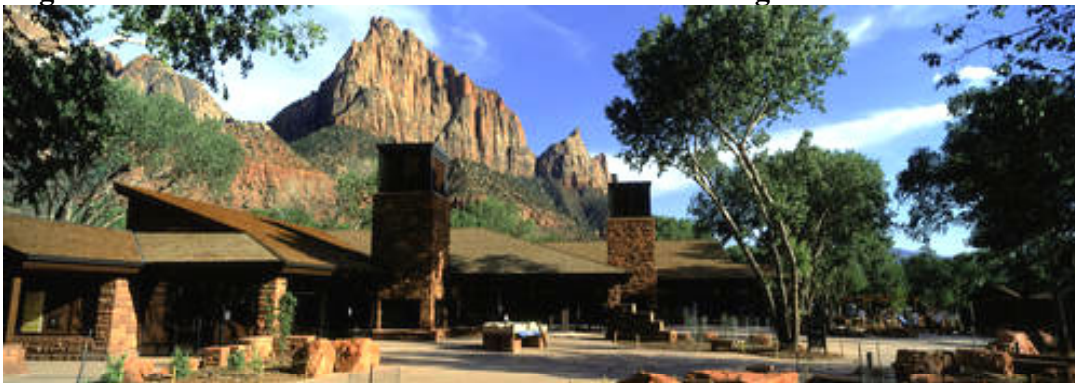
Figure 2. Zion Visitor Center North Elevation Showing Cooltowers and Plaza

The Visitor Center Complex at Zion National Park (southwest Utah) exemplifies the National Park Service's commitment to promote conservation and to minimize impact on the natural environment. The building design incorporates energy-efficient features including daylighting, natural ventilation, evaporative cooling (using passive cooltowers), passive solar heating, solar load control with engineered overhangs, computerized building controls, and an uninterrupted power supply (UPS) system integrated with the 7.2-kW PV system (Figure 2).

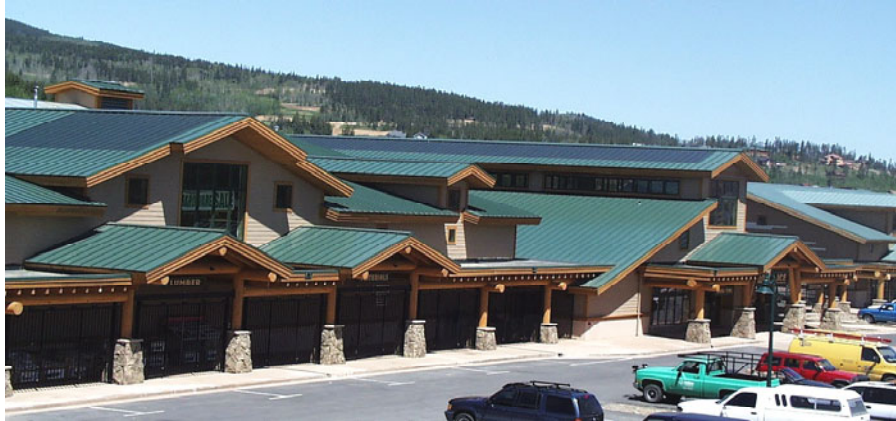
Figure 3. BigHorn Home Improvement Center

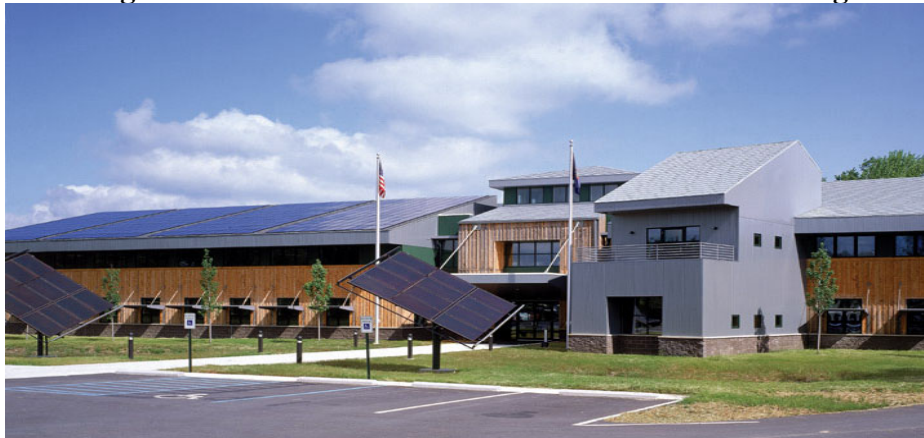
Figure 5. South Facade of the Cambria Office Building

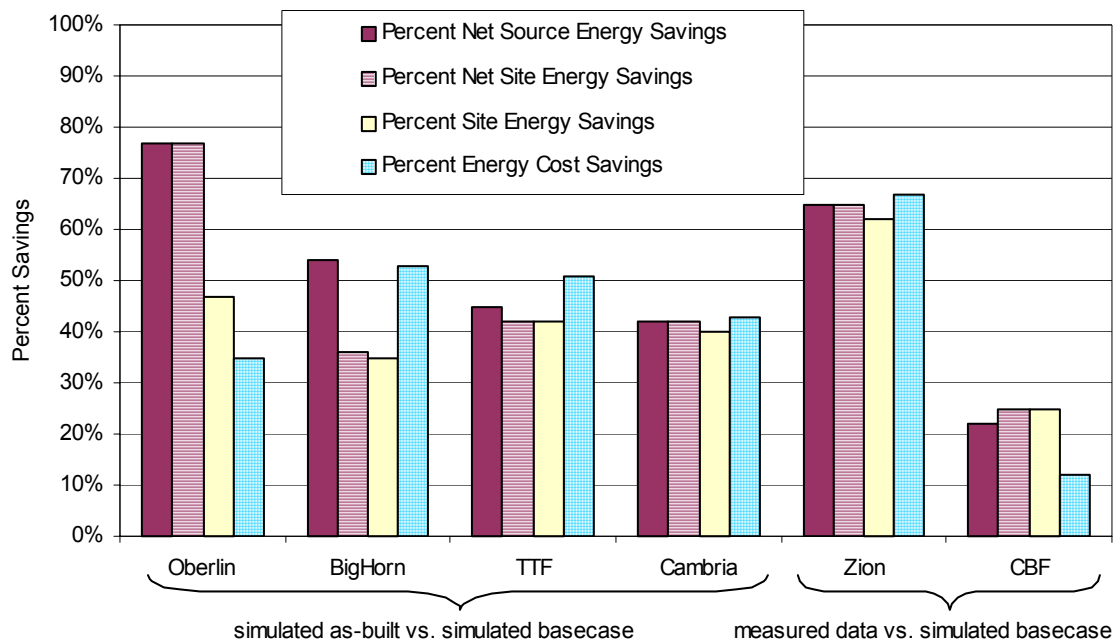
Figure 7. Summary of Building Energy Savings

Note: all bars include PV contribution except Percent Site Energy Savings.
