Field Testing of Commercial Rooftop Units Directed at Performance Verification

*David Robison, Stellar Processes
Reid Hart, Portland Energy Conservation, Inc.
Will Price, Eugene Water & Electric Board
Howard Reichmuth, New Buildings Institute*

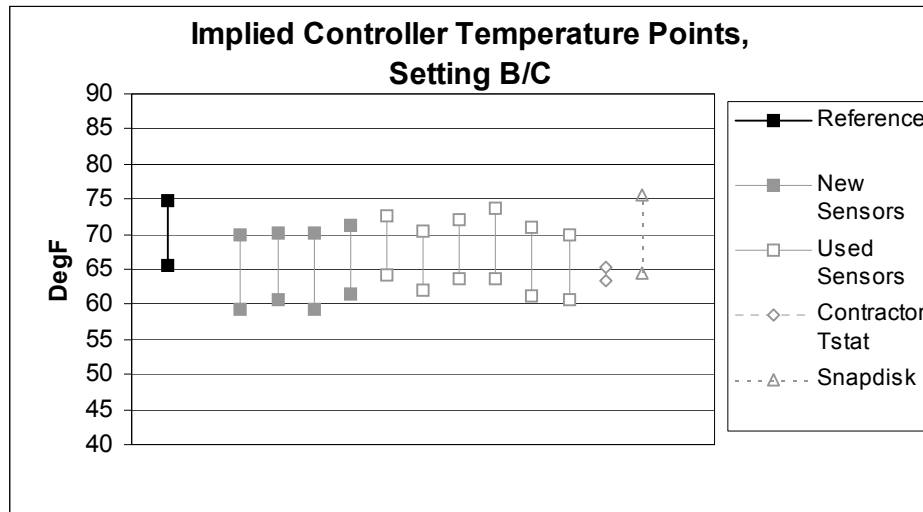
Figure 2. Comparison of Sensors

Figure 2 shows how several sensors performed at a B/C controller setting. Since the sensors are variable, it is difficult to suggest a compensating offset to the installation technician. Furthermore, such compensation would not solve the hysteresis problem. One observes relatively little difference between newly purchased and older sensors so calibration drift over time is not apparently a problem.

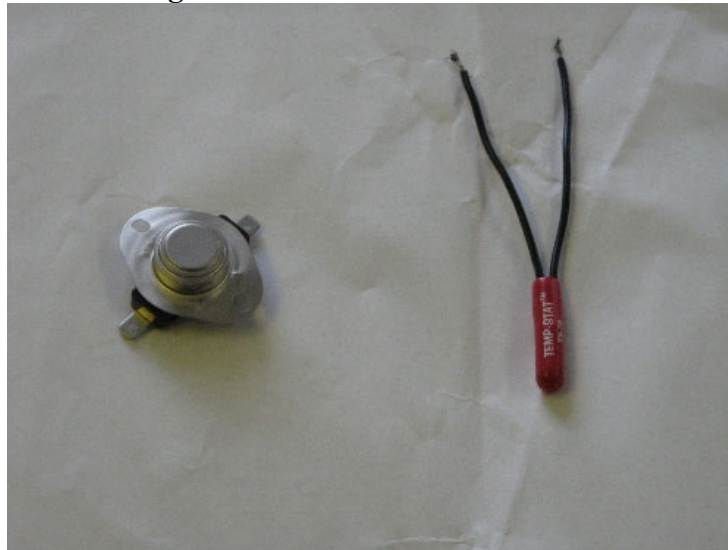
Figure 3. Alternative Thermostats

thermostats provide a solution to the accuracy problem. But the best² choice is the contractor's thermostat that permits economizing when temperatures fall to 63°F and below and continues until temperatures rise to 65°F—the narrow deadband of this thermostat is preferred because it will increase the hours of economizing. Figure 3 shows these types of thermostats.

Given that the built-in hysteresis limits operation, one might ask if there is a “work-around” solution. The research team investigated the use of a simple thermostat (close-on-fall switch, cost <\$10) to substitute for the outdoor temperature sensor. Two low-cost “contractor’s thermostats” were tested and found to be equally accurate and repeatable. The thermostat will allow economizing whenever the temperature meets the range criteria without waiting for a “reset”. Replacing the usual sensor with an on/off closure has the effect of providing a satisfying temperature input that overrides any control constraints. The closure switch is a possible workaround for the imprecision of the controller and sensors. Essentially, it bypasses the A/B/C/D settings and provides an on/off control instead. We tested another thermostat (snapdisk type, cost ~ \$25) and found them to be highly repeatable and close to specifications. However, these are slightly more expensive and they still show a 10-degree deadband. Figure 2 shows the temperature control points for these options as well. Both the snapdisk and the contractor’s

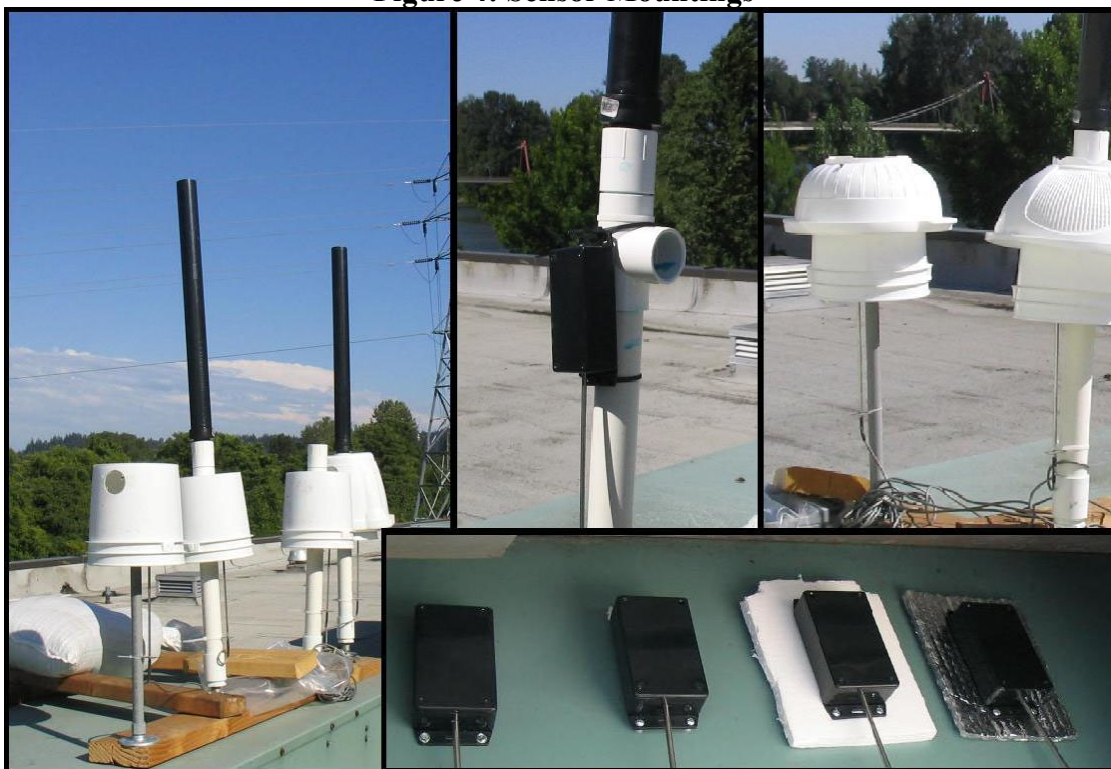
Figure 4: Sensor Mountings

Clockwise from left: Mast mounted sensors BH, BC, BV, BCS from left to right; Sensor mounting on PVC support; added white screen (inverted colander); under hood mounting from left to right: direct, air-gap, foam, bubble.

An accurate outdoor air temperature measurement is important in proper economizer changeover. To evaluate options for sensor placement, a field test was conducted in Eugene, Oregon in the late summer of 2006 to determine the impact of various outdoor air sensor treatments using low cost shields or mounting techniques. Existing rooftop units with economizers and outdoor air hoods were retrofitted with calibrated sensors using different treatments. A reference aspirated outdoor air temperature was measured with a sensor installed on the same roof at about hood intake level inside a standard six-plate radiation shield with continuous fan aspiration. Eight different configurations of sensors were tested with additional treatments.³ The sensor mountings tested are shown in Figure 4.

Designation	Description
Mast Configurations:	
BH	Mast-mount with a single bucket shield and a hole in the side of the bucket facing north.
BV	Mast-mounted with a single bucket shield and a top PVC vent, extracting air from a 'tee' in the PVC near the sensor (see "mounting on PVC support" photo in Figure 4).
BC	Mast-mounted with a top PVC vent and a 30-inch black ABS chimney to induce passive solar aspiration, extracting air from a 'tee' in the PVC near the sensor.
BCS	Mast-mounted with a top vent, black chimney, extracting air from a 'tee' in the PVC near the sensor with double nested white bucket shields.
Treatments added in successive order to mast sensor configurations (Foil is applied under hood also)	
+F	The black sensor case is wrapped in heavy-duty aluminum foil to reduce radiant heat effects. Applies to both mast and under-hood configurations.
+W	Solar gain is reduced adding a rigid white screen (inverted colander) over the bucket.

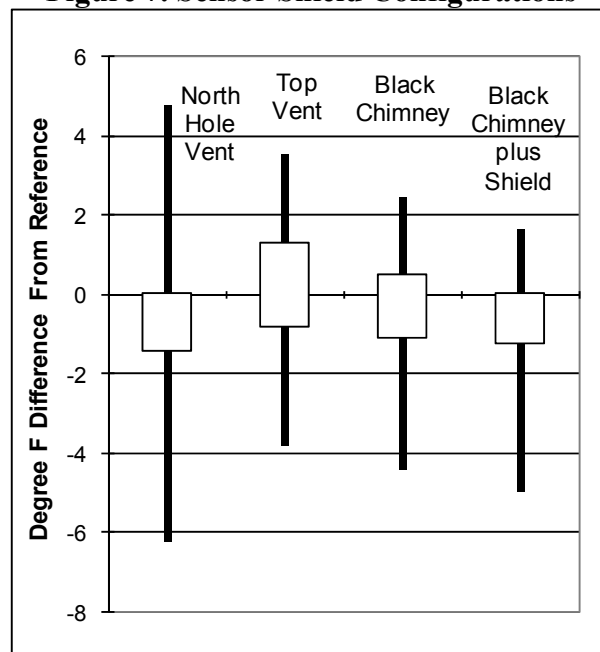
Figure 7. Sensor Shield Configurations

Note: Line indicates range of observations; box indicates middle two quartiles (50%) of observations. Observation is difference from six-plate shield aspirated sensor. Sensor shield configurations shown in Figure 7 are all with foil wrapped sensors and a white screen. Sensor treatments shown in Figure 8 are all for the basic configuration of inverted bucket with north hole vent.

The frequency and relative differences from the aspirated reference temperature for the different base configurations, all with foil and white screen treatments, are shown in Figure 7 with the difference between the screening treatments data shown in Figure 8. Wrapping the sensor package in foil significantly reduces the spread of differences to the aspirated reference temperature. A white screen added to the simplest bucket makes results acceptable without the complexity of adding a chimney. To verify differences between configurations and treatments, t-tests were completed on comparisons of interest with the following conclusions:
