Aerosol Sealing of Occupied Homes from Attics and Crawlspace

Curtis Harrington, Frederick Meyers, and Timothy Levering, UC Davis Western Cooling Efficiency Center
Dave Bohac, Center for Energy and Environment

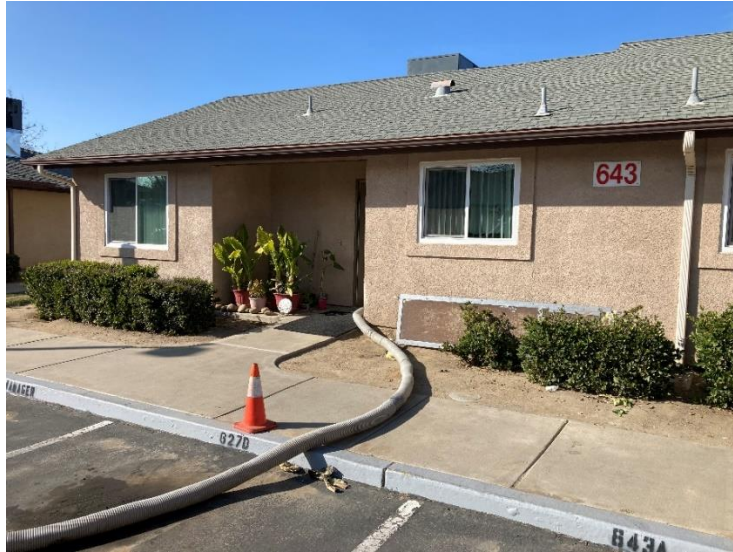
Figure 1. Apartment at Site 1 during attic insulation removal

Test Site 1 was the first application of the exterior aerosol sealing approach. The apartments tested were all single-story with two floorplans—938 ft² and 764 ft². The apartments were slab-on-grade with ventilated attics so only the attics were targeted for the sealing process (Figure 1). In all cases, the attic insulation was removed prior to the sealing so pre and post air

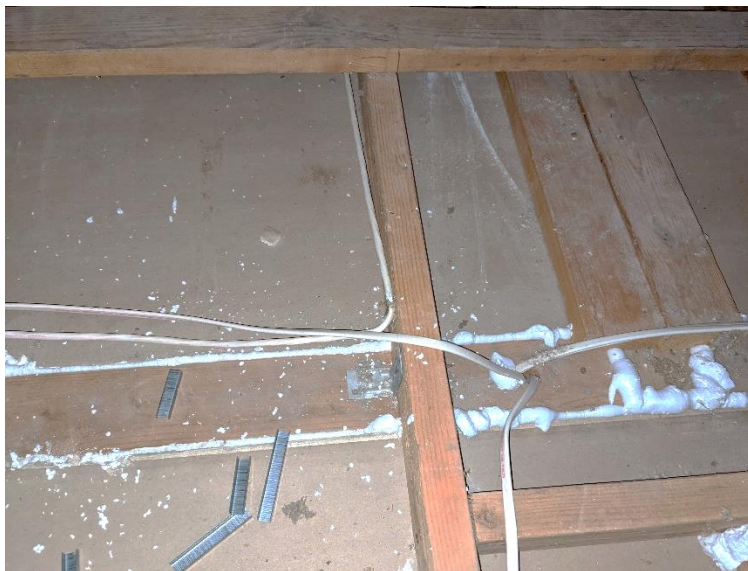
Figure 3. Photo of seals formed with can foam during manual sealing effort

Manual sealing. Manual sealing with expanding foam in pressurized cans was applied to two apartments and considered the “business as usual” approach by the contractors. After vacuuming the insulation, a team of two entered each attic and sprayed foam on wall caps, electrical penetrations, and register boots. How and where foam was applied was entirely up to the experience of the technician. Each attic took approximately 90 minutes to seal using this method. The manually sealed attics achieved a leakage reduction in the homes by an average of 14% from an initial leakage of 7.2 ACH50 to a final leakage of 6.2 ACH50.

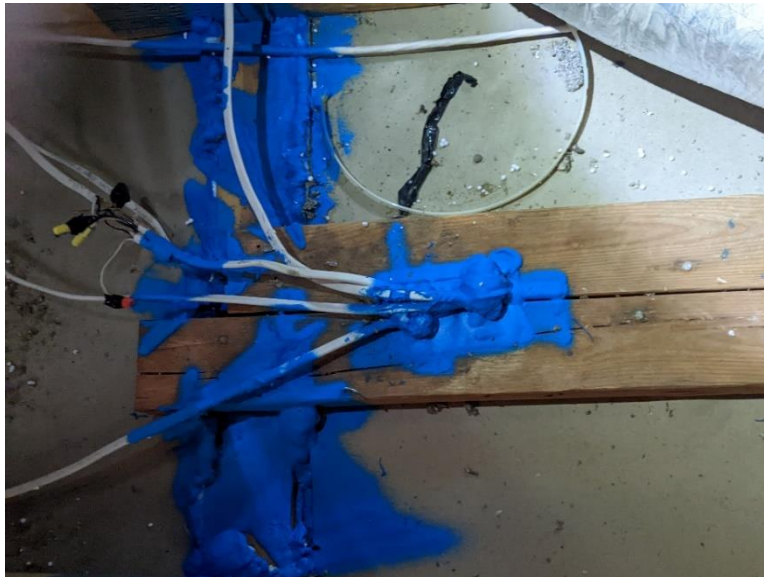
Figure 4. Photo of elastomeric seal product in attic

Researchers were able to observe the application of the elastomeric paint and take measurements before and after. The application process was labor intensive and required a trained operator to properly apply on wall caps, mechanical and electrical penetrations, and other common leak sites. The product requires a powerful airless sprayer which one person operated while another fed hoses and replaced buckets as needed. Each attic took approximately 2.5 hours to seal with this product, including time to address issues with the nozzle clogging and sprayer motor overheating. The three apartments with this product applied had an average leakage reduction of 23% from 7.9 ACH50 to 6.1 ACH50.

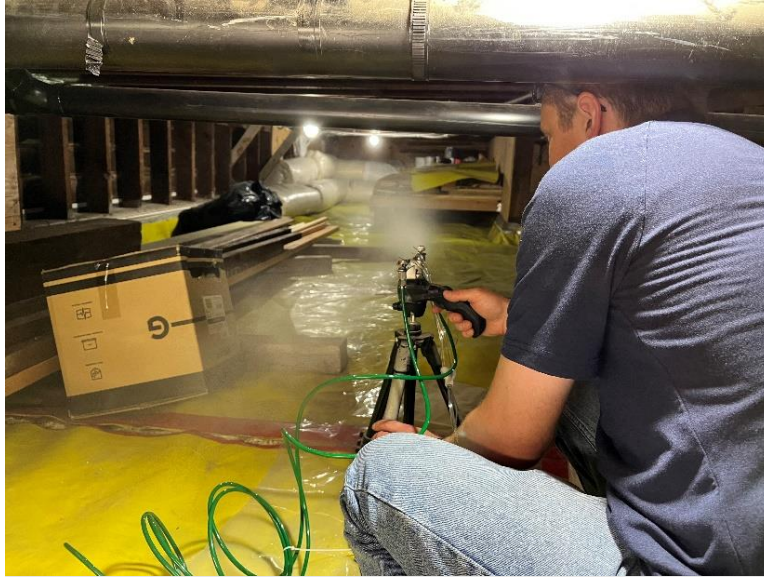
Figure 5. Aerosol sprayer setup in crawlspace at Site 2. Water is used to check functionality before injecting sealant.

Four nozzles were installed with each set of nozzles placed in the center of the crawlspace and pointed in opposite directions along the length of the house. Fogging inside the house was noticeable, but very minor and no deposition on contents was observed. One window was opened a small amount to clear out some aerosol without affecting the sealing process (pressure was maintained), but the impact of this strategy on the indoor fogging was unclear. Particulate matter sensing inside the home was conducted in later tests at Sites 4 and 5. The process took about 1 hour and sealed 247 CFM50 or 35% of the overall house leakage, reducing the total leakage to 1.9 ACH50. This also amounted to 87% of the leakage through the floor, and later guarded testing showed no measurable pressurization of the main home when pressurizing the basement, demonstrating that very little leakage connection remained between the zones.

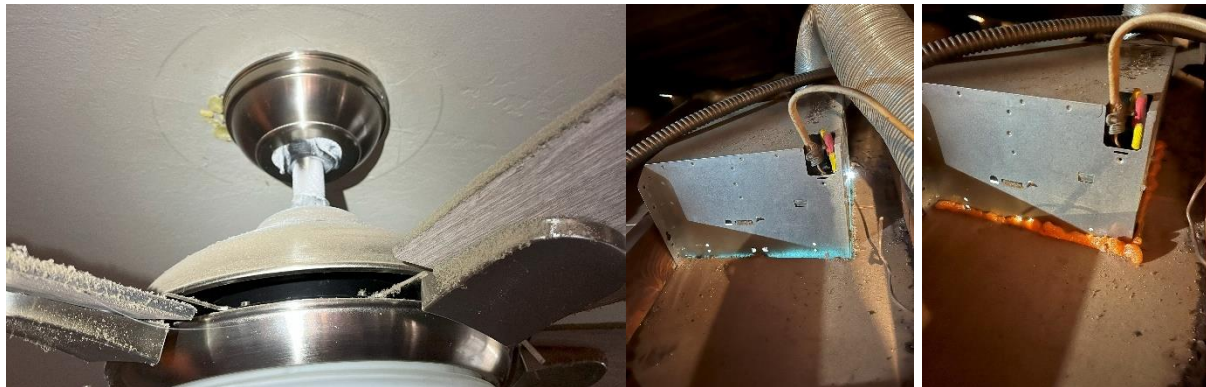
Figure 6. Photo of sealant buildup on ceiling fan (left), and foam applied around bath fan housing (middle and right)

Site 4 site was a 1,191 ft² one-story single-family home with a vented attic and crawlspace. The owner was in the process of replacing the HVAC system and windows so there were some rough openings that had to be temporarily blocked for the sealing work. Prep work was minor with some holes in the wall from renovation work that needed to be taped over. In addition, the attic access hole was covered with a plywood board screwed into the ceiling and crawlspace access was taped at the seams to avoid sealing the door. The only manual sealing was a small amount of canned foam around a bath fan housing.

The crawlspace access was very tight with abandoned ductwork making it difficult to navigate, and some areas were not visible at all. Compressed air for the injectors was routed around the outside of the house through a crawlspace vent. Due to the limited access in the crawlspace, proper development of a high-humidity aerosol fog faced multiple challenges and resulted in humidity levels that were lower than optimal. Even with these challenges, the aerosol sealing process was very effective. The initial house leakage was 1,628 CFM50 or 10.2 ACH50, and sealing was able to reduce that by 596 CFM50 (3.7 ACH50) or 37%, for an end result of 5.7 ACH50. The lack of adequate fogging due to limitations with the prototype equipment caused sealing rates to be slow. Ultimately, the research team ran out of time before fully completing the sealing. This impacted the total amount of sealing accomplished, and it is expected that additional nozzles would have resulted in more leakage sealed and faster sealing rates. After sealing, some deposition was noted on the ball-joint in a ceiling fan (Figure 6). This deposition was easily cleaned but was noted as an area potentially requiring surface protection in future installations.

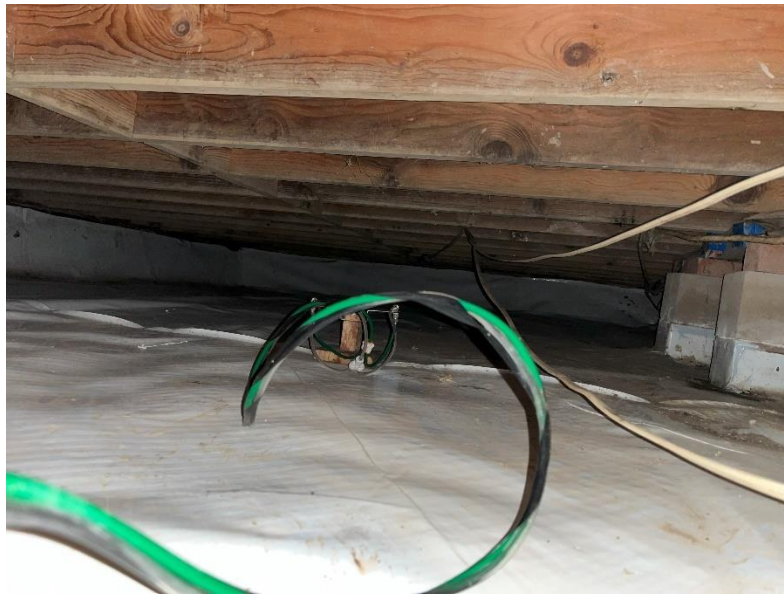
Figure 7. Photo of crawlspace sealed at Site 4

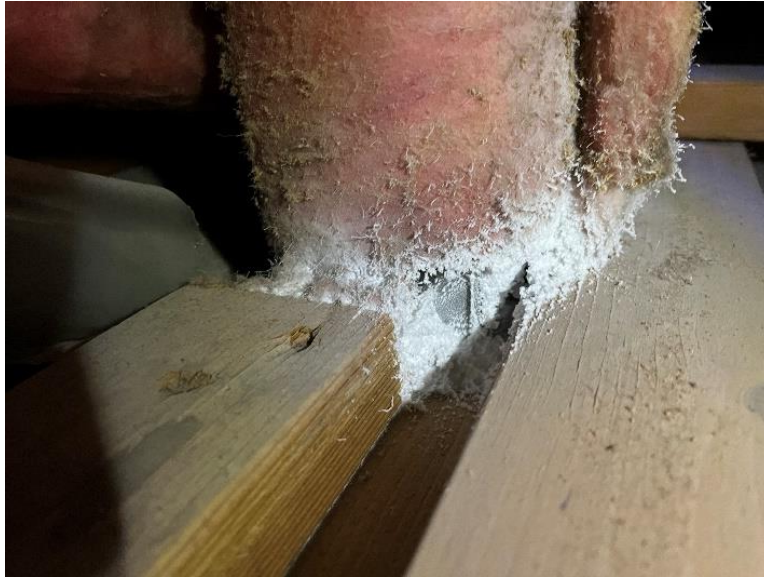
Figure 8. Sealant deposition on ductwork at register boot connection

Another advantage of the attic and crawlspace sealing approach is that any ductwork in those locations in the building could potentially be sealed in the process. Site 6 had metal ductwork present in the attic, and a duct leakage test before and after sealing was performed to determine the impact on duct leakage. The metal ducts were wrapped in fiberglass insulation which was not removed as part of the attic insulation removal process. The insulation on the ductwork impacted the duct sealing effectiveness, but the exposed parts near register boot connections were available to be sealed (Figure 8). Overall, the process sealed 133 CFM25 or 34% of the total duct leakage. There were signs of leakage beneath the insulation as evident by

sealant buildup on the insulation and it is expected that removing the duct insulation prior to sealing would have resulted in better performance.

The attic sealing approach also showed the ability to seal duct leaks at the same time with 34% of the duct leakage sealed in Site 6. The duct sealing process would have been more successful if the insulation was removed from the duct prior to sealing. Significant sealant deposition was found on the insulation material suggesting leaks that exist below the insulation. Insulation acts as a filter preventing the aerosol from reaching and sealing leaks reducing sealing rates and effectiveness.

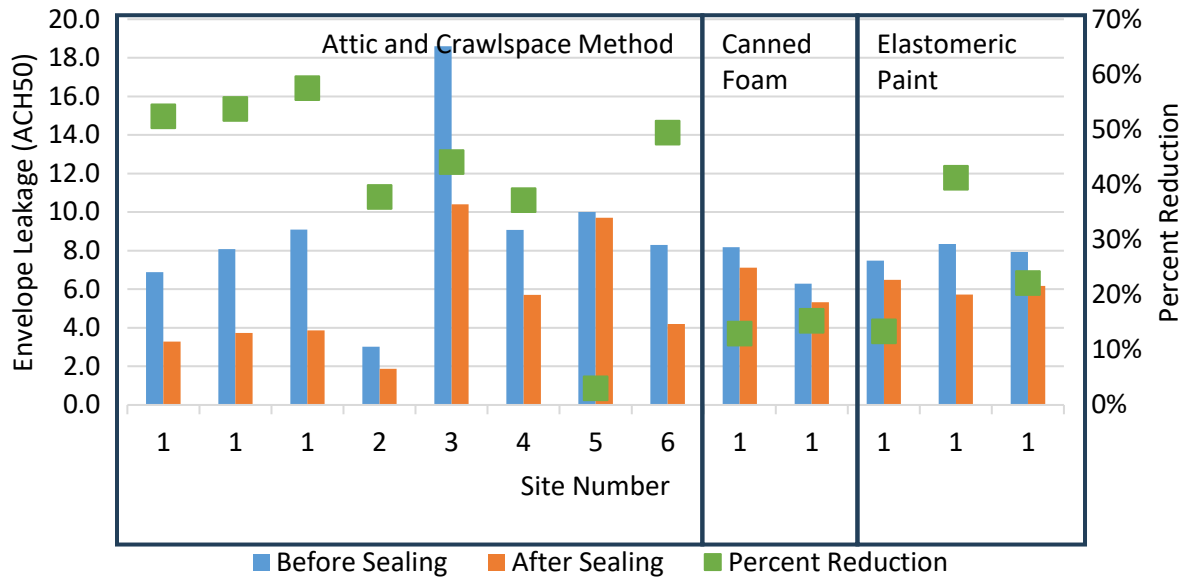
Figure 9. Summary of sealing results for the aerosol sealing method vs. other sealing approaches

The average leakage reduction for the aerosol method was 42% compared to 14% for manual foam sealing and 23% for the spray-applied elastomeric. Four of the eight aerosol sealing efforts resulted in a leakage reduction of more than 50%, which is impressive considering the application is limited to only one or two key surfaces in the home (i.e., ceiling-attic surface, or floor-crawlspace surface). The homes with the largest reductions were all in applications where the sealing was performed only from the attic. This could be due to the fact that gravity settling of particles works in favor of the attic application or elevated temperatures allows for higher particle concentrations, but more testing of the process in crawlspaces is needed to investigate this observation.
