Field Investigation of Duct System Performance in California Light Commercial Buildings (Round II)

Wm. Woody Delp, Nance E. Matson, Darryl J. Dickerhoff, and Mark P. Modera, Lawrence Berkeley National Laboratory, Berkeley, CA

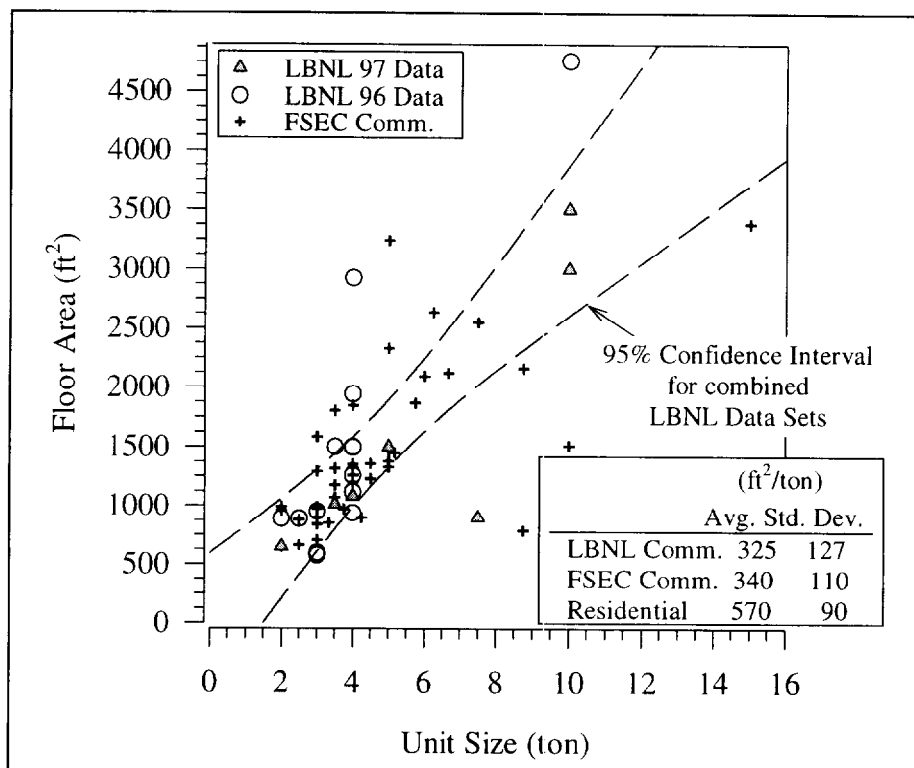
Figure 1. Floor area -vs- unit size: using the 1996 and 1997 LBNL and FSEC (Cummings, et al., 1996) commercial data along with residential (Jump, et al., 1996) summary information. The FSEC unit size is derived from the total installed capacity in the building divided by the number of units.

Figure 1 shows the floor area versus the unit size, for both the LBNL and the FSEC data sets. The important point here is the floor area served by each unit. This figure shows that the California (LBNL) buildings are similar to those in Florida (FSEC). Light-commercial buildings frequently have a greater load density (ton/ft^2) than single-family residential homes, due to internal loads such as equipment, lights, and people. Unfortunately with many light-commercial buildings accurate load information is not available during design, and contractors/engineers resort to a rule-of-thumb approach to equipment selection, often resulting in oversized equipment. (Less than half of the systems tested had any plans.) It is worth noting the values in the figures are installed capacities, and do not necessarily correspond to actual space loads.

The twenty-five systems had an average unit size of 4.9 tons, this compares with the FSEC data of 4.5 tons, and the residential of 2.9 tons (Jump, et al., 1996).

The average floor area served by each unit was 1,575 ft² for the current study, 1,400 ft² for the FSEC buildings, and 1,800 ft² for the residential buildings. Since the area served by each commercial unit is smaller than residential, and the units have a greater capacity, commercial buildings have larger units on a floor area basis than residential buildings. The commercial buildings averaged between 325 and 340 ft²/ton while the California residential buildings averaged 570 ft²/ton. Assuming duct loss mechanisms scale with capacity, this indicates light-commercial buildings potentially have greater duct losses on a building floor area basis than residential buildings.

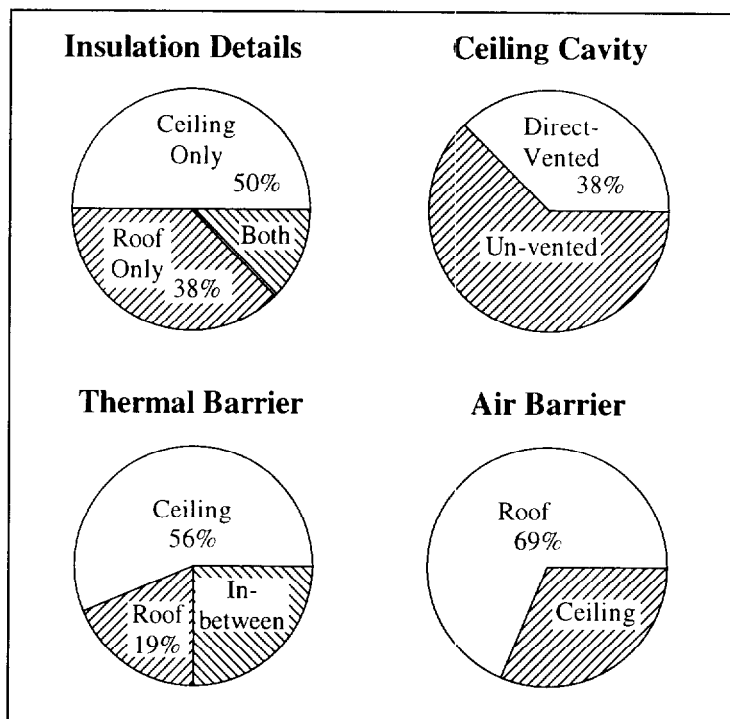
Figure 2. Building thermal and air barrier characterization for the 1996 and 1997 LBNL commercial buildings.

In order to understand the dynamics of duct losses, details of the building need to be determined. Figure 2 summarizes many of the characterization details pertaining to the buildings. All the buildings had a drop ceiling with the duct runs in the ceiling cavity. Because of this, two critical building details are the location of the thermal and the air barrier. Fifty percent of the buildings had insulation placed at the roof deck, 38% on the ceiling tiles, and the remainder had insulation at both locations. Thirty eight percent of the buildings had a directly vented ceiling cavity. In these buildings, the lay-in acoustical ceiling tiles formed the major air barrier. In 56% of the buildings the primary thermal barrier was at the ceiling tiles, which implies that the ducts are entirely outside the conditioned space. In 25% of the buildings the ceiling cavity acted like a buffer zone, with the temperature floating between the room and outside temperatures. With these buildings, the thermal barrier is in-between the roof and ceiling. In the remainder of the buildings the thermal barrier was at the roof, however even in these buildings, the ceiling cavity temperature was slightly higher than the room.

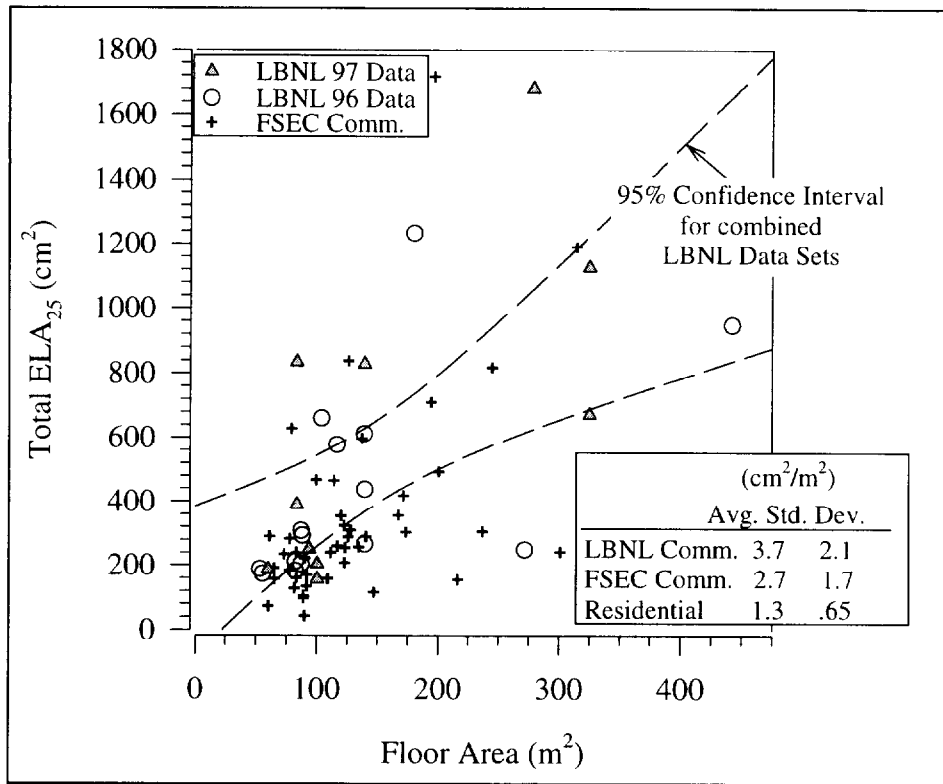
Figure 5. Combined leakage area (ELA₂₅) -vs- floor area using the 1996 and 1997 LBNL and FSEC (Cummings, et al., 1996) commercial data along with residential (Jump, et al., 1996) summary information. Combined leakage area includes both supply and return leakage.

Figure 5 shows the combined leakage area (ELA₂₅) versus the floor area for both commercial data sets. Again, the data show a large spread in values. The dashed lines in the figure represent the 95% confidence interval for a linear regression on the combined LBNL data sets. The LBNL data grouping is similar to, and slightly higher than, the FSEC data. As an order of magnitude estimator on a larger stock of buildings, in residential work, it is common to present building envelope leakage results by normalizing leakage area with floor area (cm²/m²). The average cm²/m² in the LBNL data set was 2.8 times that of the residential data, while the FSEC data was just over 2 times the residential. These data suggest that light-commercial duct systems leak air at a rate much greater than residential systems, for any given floor area.
