Through the looking glass: analyzing barriers to adoption of advanced rooftop unit controls through human-centered observational research

*Shreya Agarwal, Marco Pritoni, Lawrence Berkeley National Laboratory
Jessica Collier, Jeff Wanner, Ruth Taylor, Meghan McNulty, Pacific Northwest National
Laboratory
Mary M. Bryan, MMB Energy Engineering*

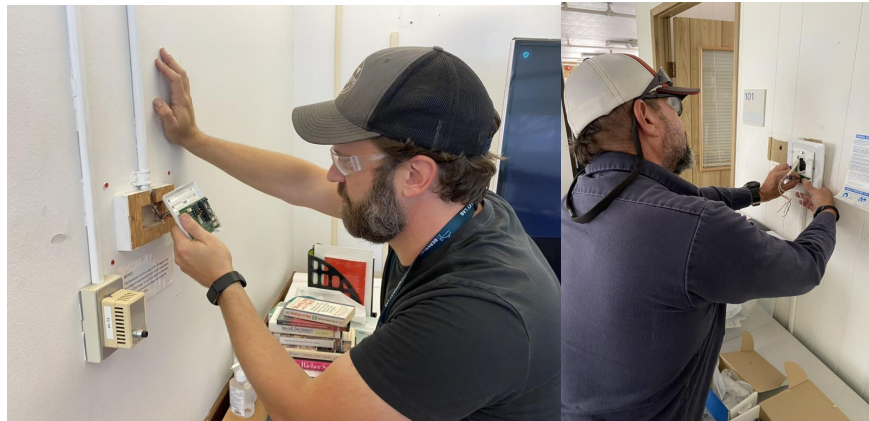
Figure 6. Images of ICs installing networked thermostats.

3. Due to a high number of interacting components and slow dynamics, the commissioning processes for HVAC controls is long and tedious. In all of the observations we conducted, configuration of thermostats, especially the ones that provided additional capability (i.e., demand-controlled ventilation or occupancy sensors) took the longest time. To address these issues, a simplified and clear commissioning process can reduce the time and effort required to configure and commission new devices. Images in Figure 6 show ICs inspecting thermostat wiring.
